Release Notice

These are software release notes for GreenStar™ 3 2630 and related products. Release Notes can be found on www.stellarsupport.com. Note: Your use of the software is governed by the End User License Agreement included with the software.

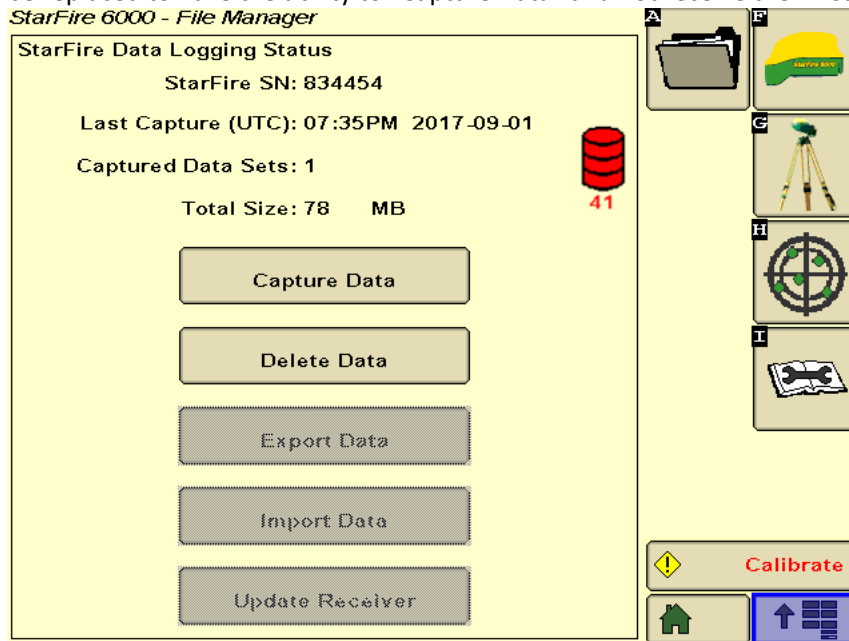
File Manager Defect – A new icon has been implemented to detect an internal hardware failure. After installing 18-1 software, there could be a red icon with the number 41 present, if an internal hardware failure is detected. The receiver will function as normal, but if the “Capture Data” button is pressed, the user will get the error of “Insufficient Storage” and not be able to collect data. The receiver will need to be replaced to have the ability to “Capture Data” and not receive the “Insufficient Storage” error.
