# GreenStar™ Displays

Software Update 20-2 Release Notes  
3.36.1073

JOHN DEERE

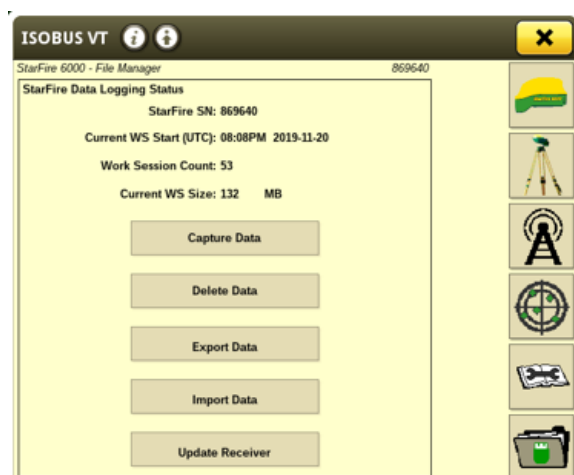
### **Continuous Data Logging**

Diagnostic information is continuously logged internally on the StarFire™ 6000 receiver as individual work sessions from ignition on to ignition off with a maximum work session length of two hours. When a work session exceeds two hours, a new work session will automatically begin. Up to 48 hours of work sessions can be recorded.
